GEOTECHNICAL SITE INVESTIGATION

Prepared by ASCT - Parkes office, for Cabonne Shire Council

70 Gaskill Street, Canowindra, NSW, 2804.

Re: Proposed Floor Replacement of Existing Building, 70 Gaskill Street Canowindra NSW 2804.

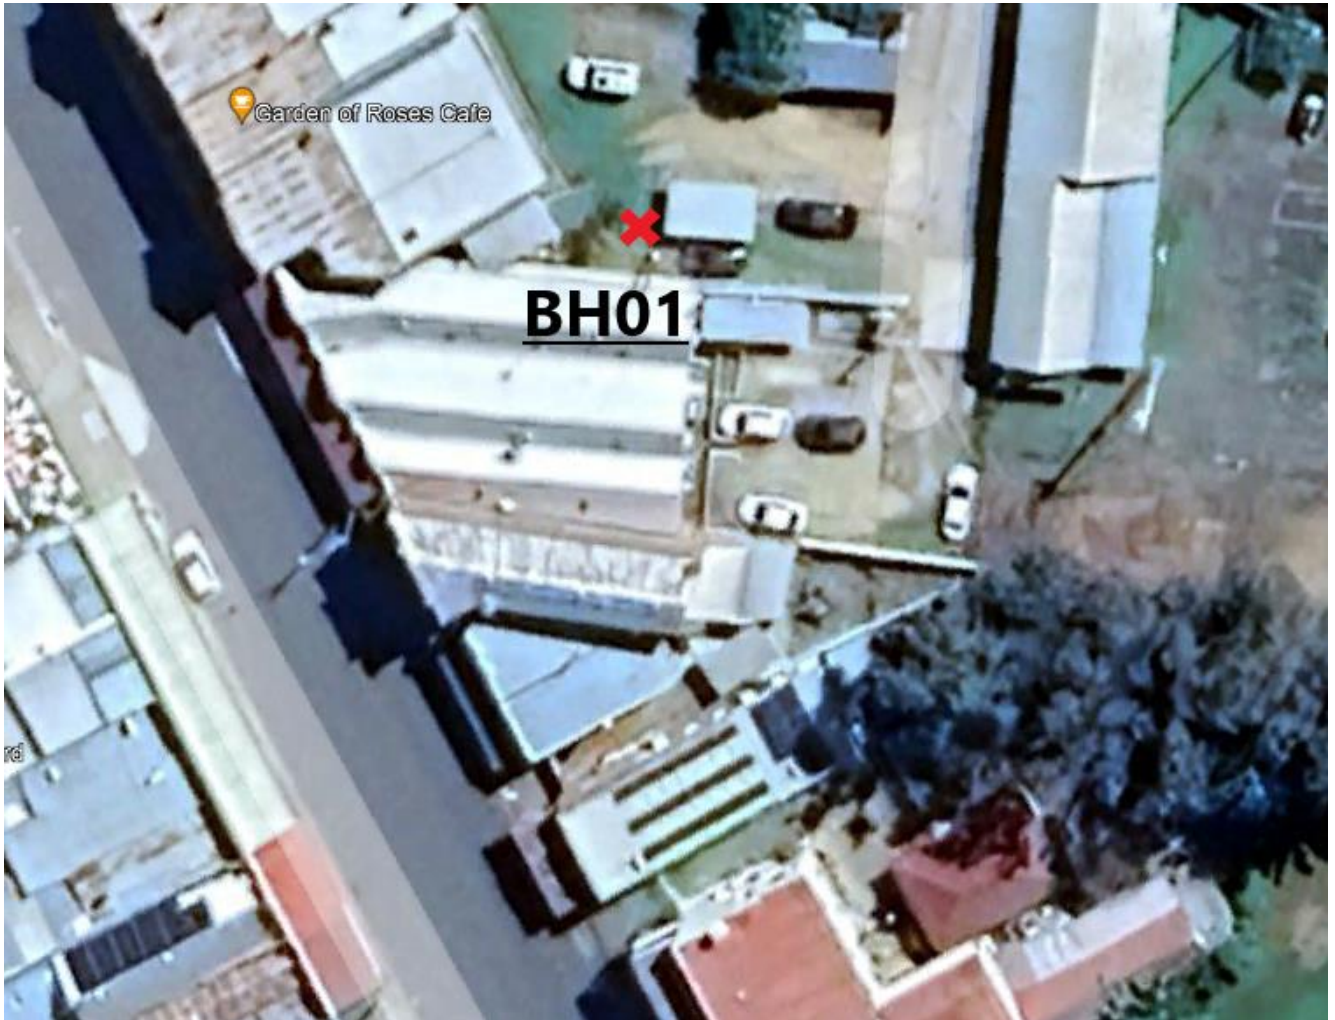
Overhead view of the site showing ASCT approximate test locations.
