Cabonne Council
Canowindra Sewage Treatment Plant
Pollution Incident Response Management Plan

July 2024

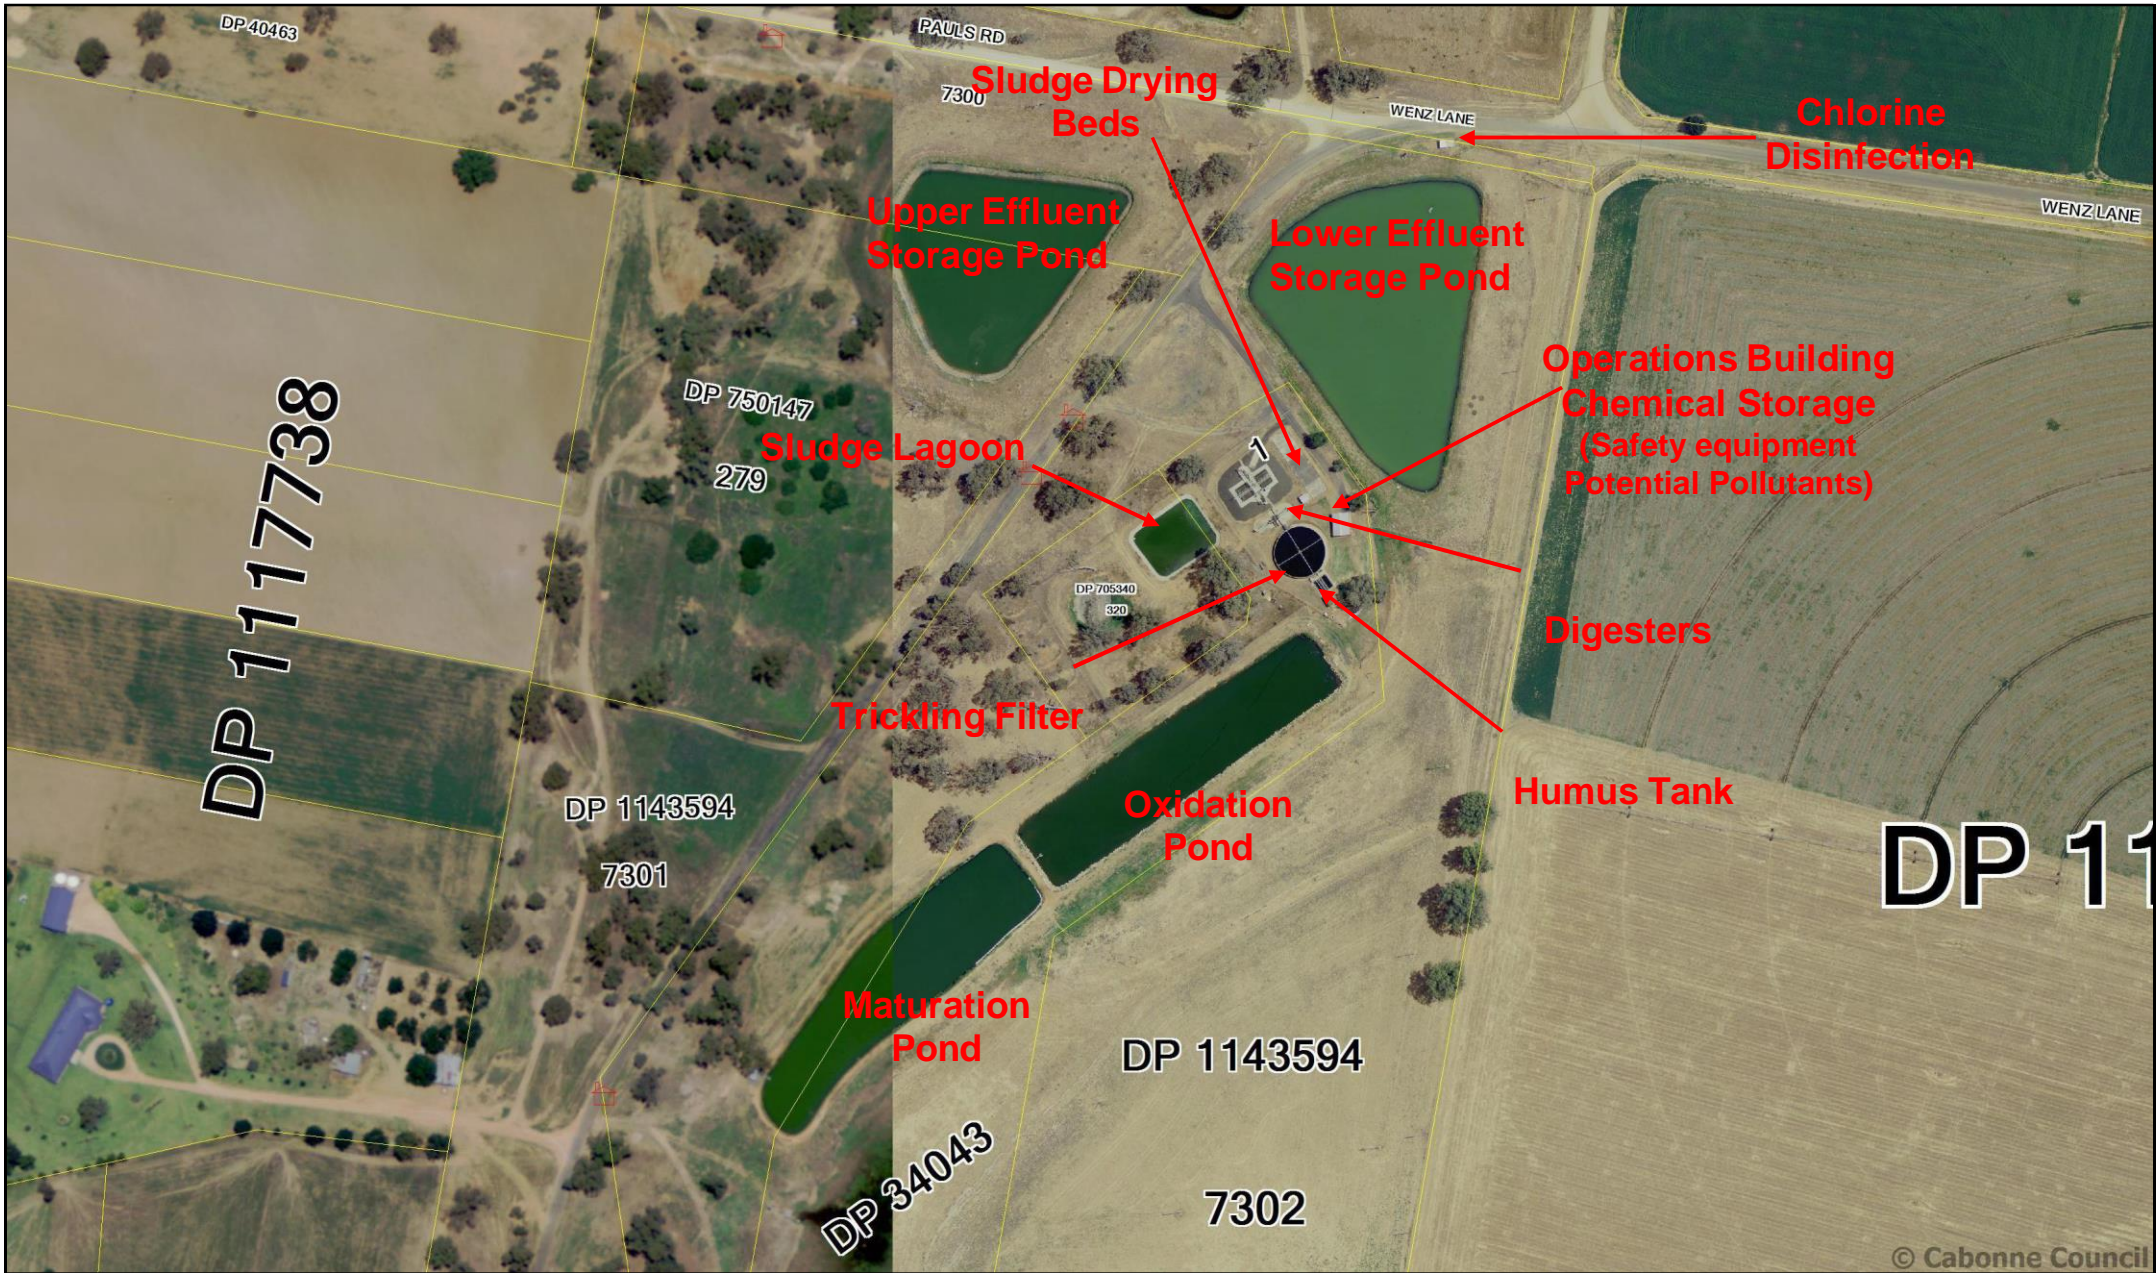
- Canowindra locality map
- Canowindra STP features map.

Details of potential pollutants and safety equipment are provided in Table 2-2. The location of the items listed is shown on the maps in Appendix B.

Pollution incident response maps have been prepared to facilitate planning for incident response and provide readily accessible and accurate information to support the assessment of an incident and assist in the implementation of incident response procedures and clean-up.
